Monthly Oversight Report 58
44728 AES [46526 RAC]
ACS NPL Site
Griffith, Indiana
October 1, 2005 – November 4, 2005

Subject: Monthly Oversight Summary Report
No. 58 for October 2005

Monthly Oversight Summary Report No. 58
ACS Superfund Site
TO 057, 44728.238 (AES) [WA57, 46526.238 (RAC)]

Reporting Period: Month of October (October 1, 2005 – November 4, 2005)

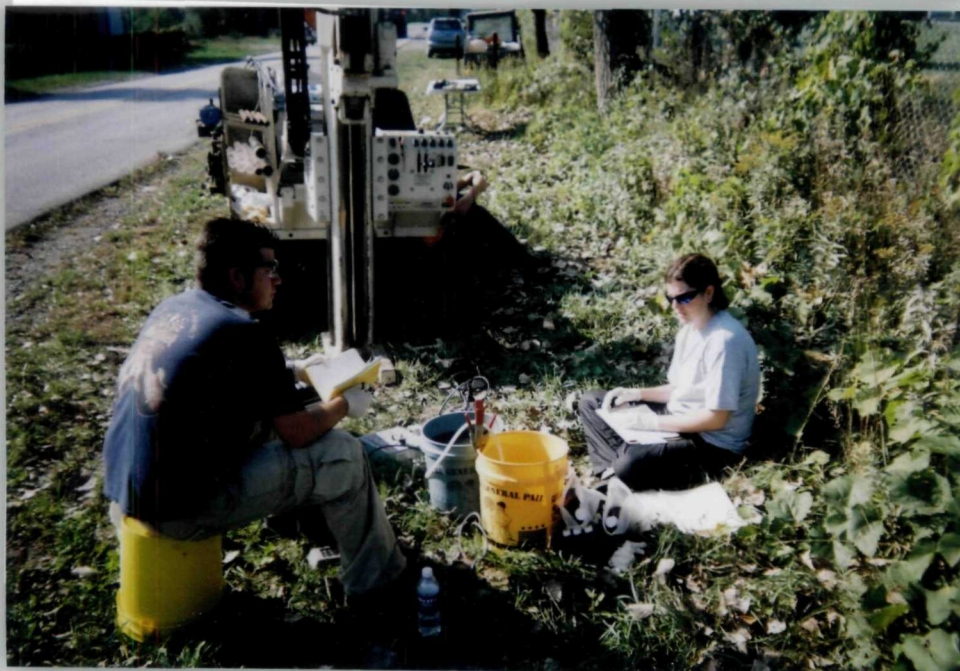
Description: Photo facing south showing MWH purging groundwater at DL10 as part of the soil and groundwater sampling after the 3rd post-application chem-ox injections.

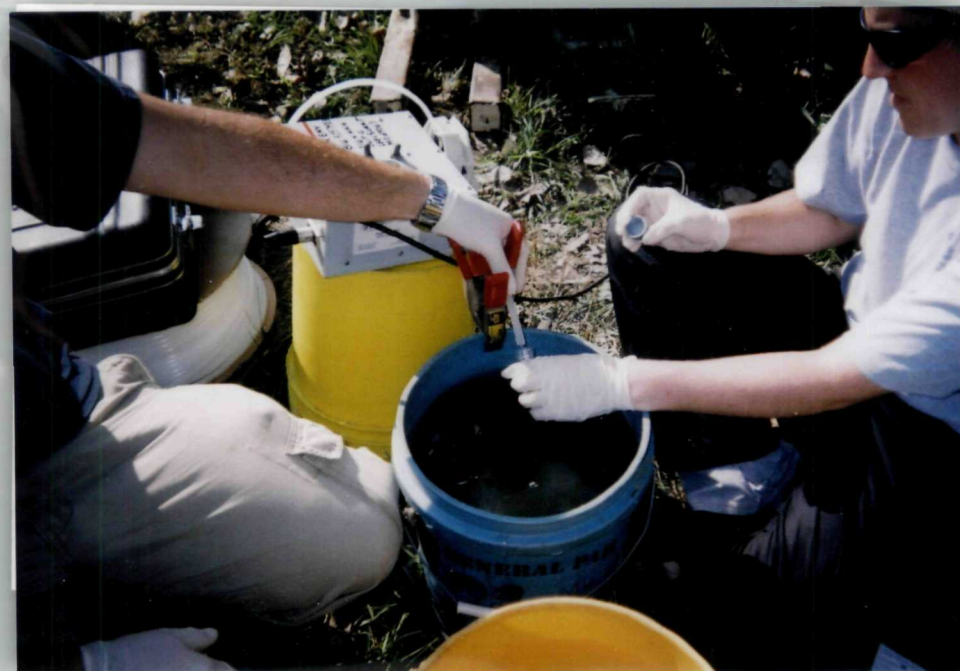
Description: Photo facing south showing MWH collecting VOC groundwater sample from DL10 on west side of Colfax Ave.

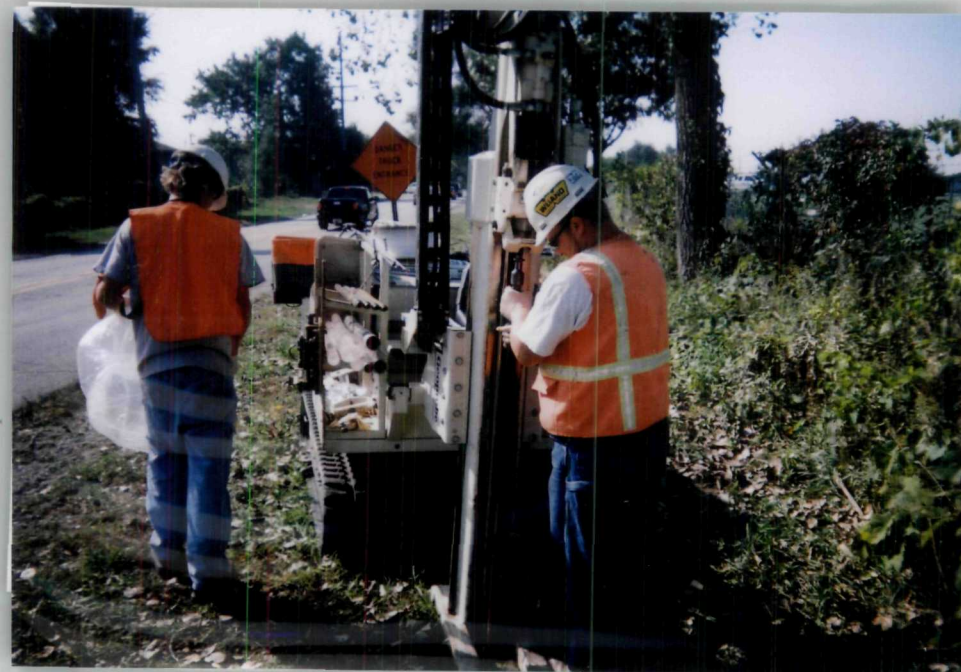
Description: Photo facing south showing PSA
Environmental removing drill rod from
DL10 after sampling.

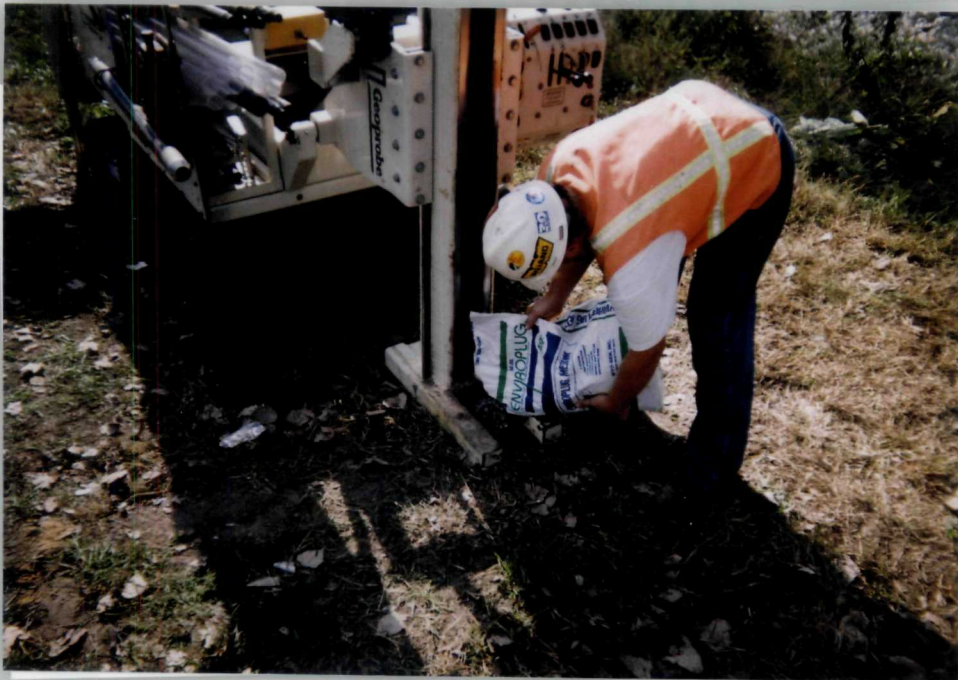
Site: American Chemical Service, Inc.
 Proj. #: 44728 AES [46526 RAC]
 Roll: 79 Photo #10
 Date: 10-04-05 Time: 1455
 Photographer: Larry Campbell
 Description: Photo facing southwest showing PSA
 Environmental backfilling DL02 probe hole
 with bentonite pellets.

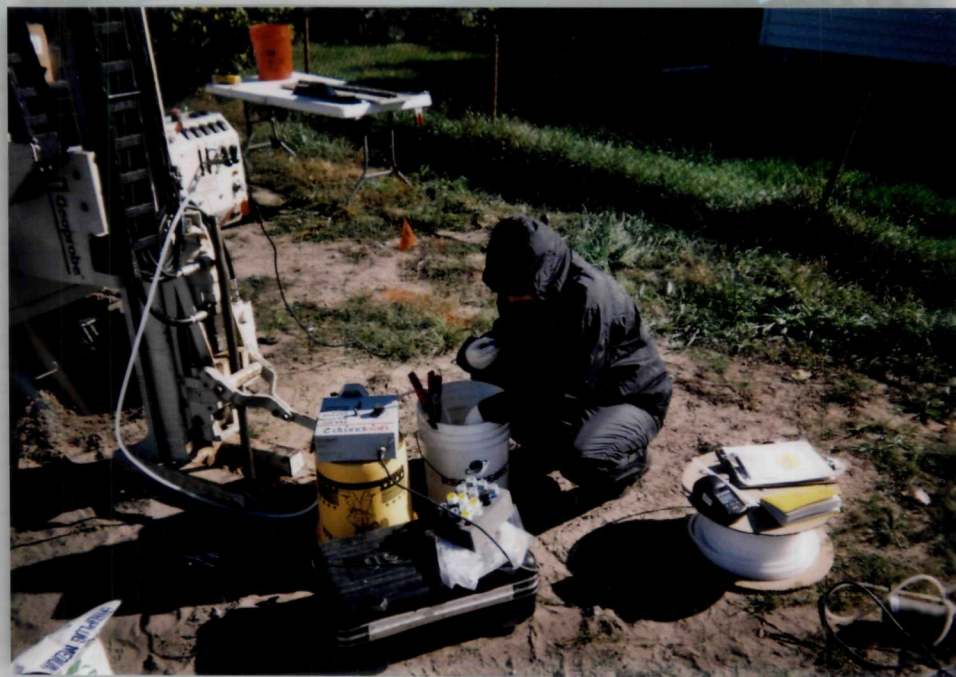
Site: American Chemical Service, Inc.
 Proj. #: 44728 AES [46526 RAC]
 Roll: 79 Photo #11
 Date: 10-06-05 Time: 0930
 Photographer: Larry Campbell
 Description: Photo facing northeast showing MWH
 collecting groundwater sample from FS3-
 02.

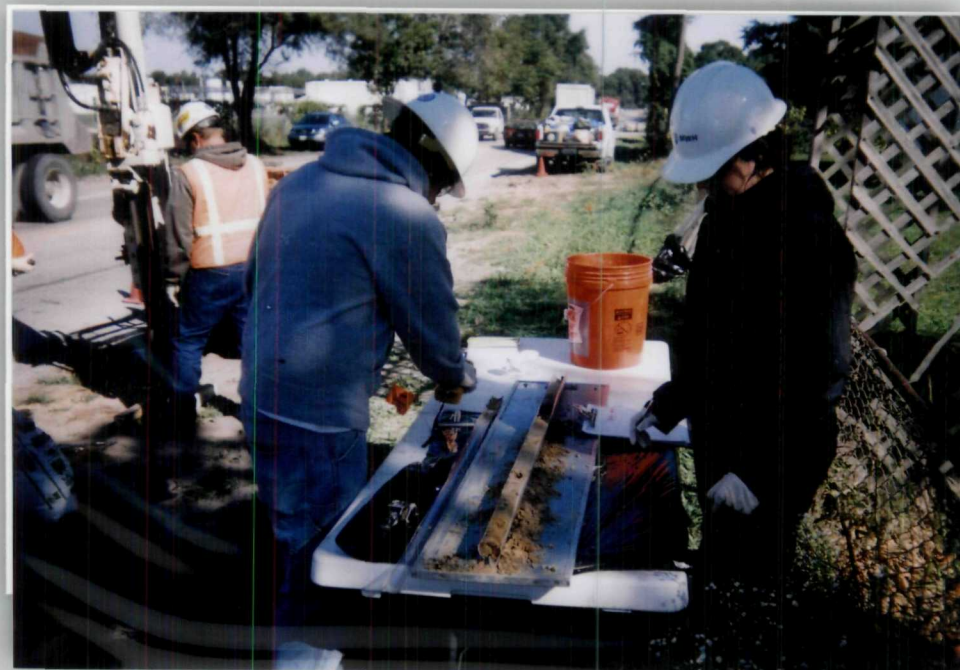
Description: Photo facing north showing MWH
examining soil sample from FS3-08 on east
side of Colfax Ave.

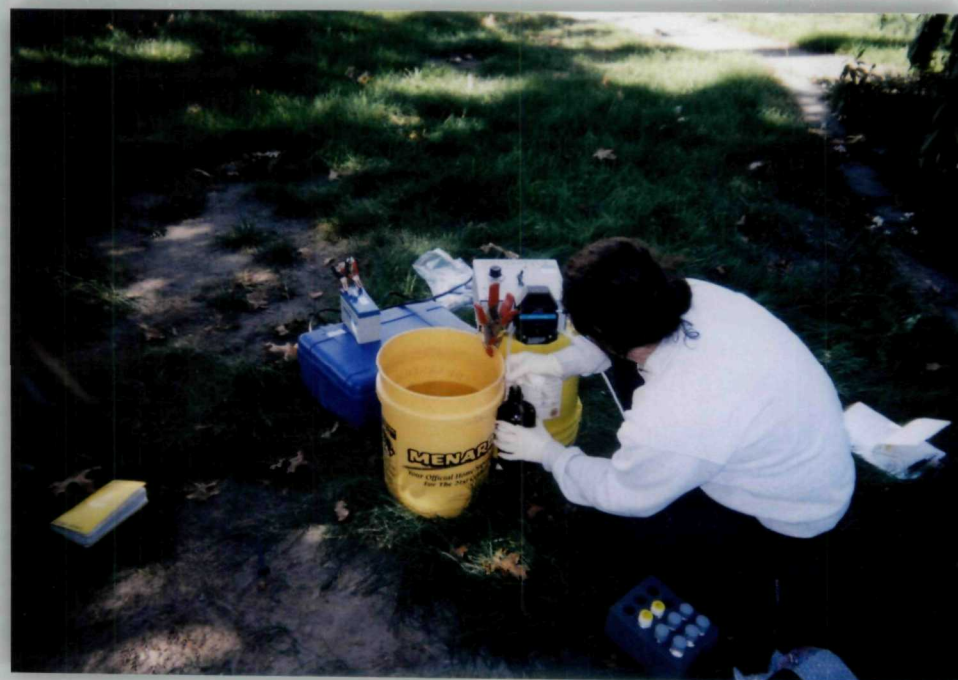
Description: Photo facing west showing MWH collecting groundwater sample in 1 L bottle from ORC-PZ-105.

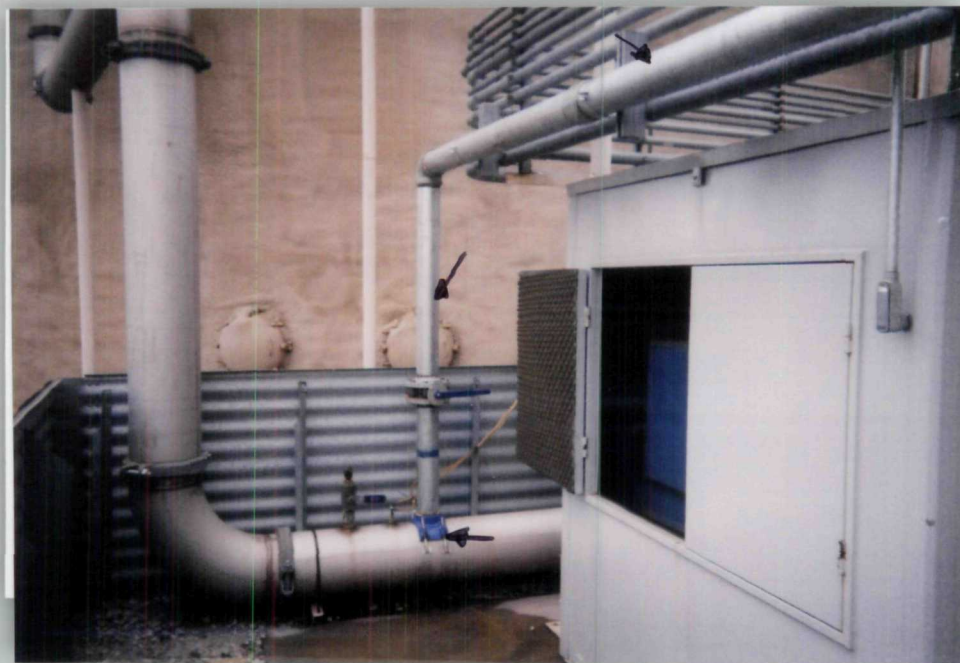
Description: Photo facing south showing new 4" dia. stainless steel pipe (arrows) added to existing air header to provide injection air for the SBPA ISVE system upgrade.

MWH reported that the planned upgrades to the SBPA ISVE system have been completed. All modifications in the GWTP and the SBPA blower shed have been completed. MWH attempted to startup the SBPA ISVE air injection system on October 20, but found that the friction caps on the tops of the ISVE wells were blown off when the wells were pressurized to 10 psi. MWH ordered and installed higher pressure caps on the wells being converted to air injection wells. MWH measured volatile organic compound (VOC) concentrations as large as 7 ppm in the SBPA ISVE blower shed during air injection testing. MWH found cracks in the piping header system in the blower shed and replaced the damaged sections.

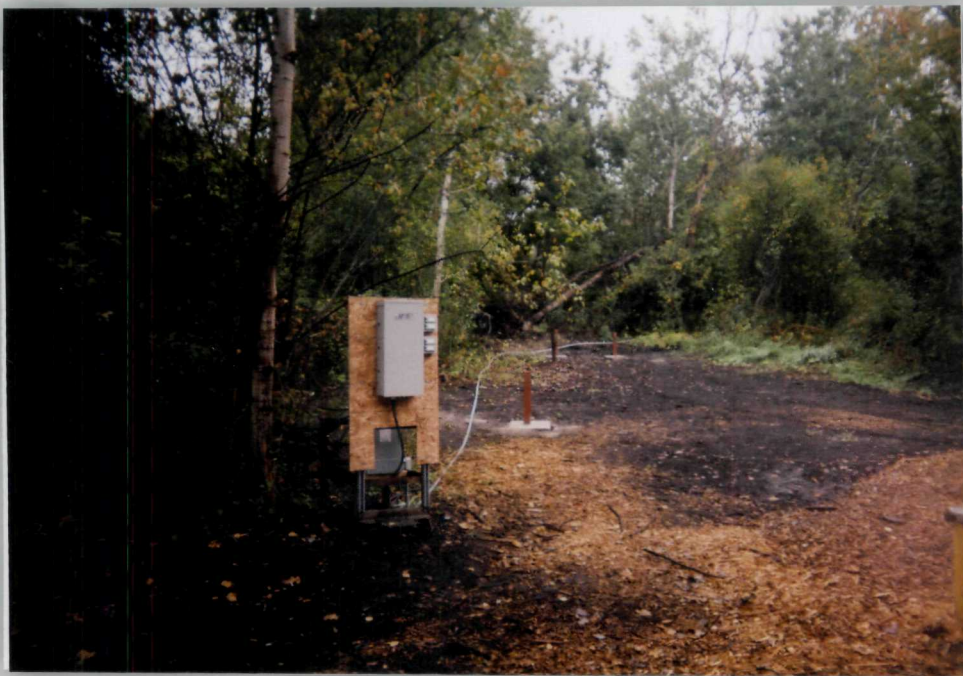
Description: Photo facing east showing new electrical panel adjacent to lower aquifer pump test well EW02.

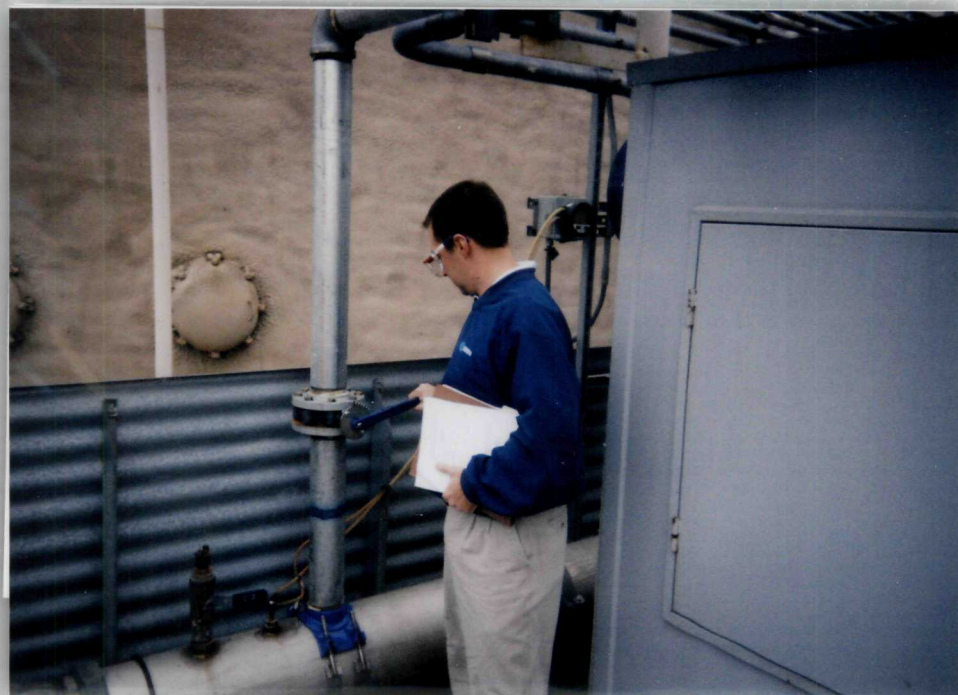
Description: Photo facing southwest showing Chris Daly adjusting main air valve to reduce pressure going to SBPA ISVE air injection system.

0925 Disc w/ Lee & Chris Daly
Started injecting air into
newly converted ISVE wells
in SBPA. At 10 PSI, found
they were blowing caps off of
ISVE injection wells

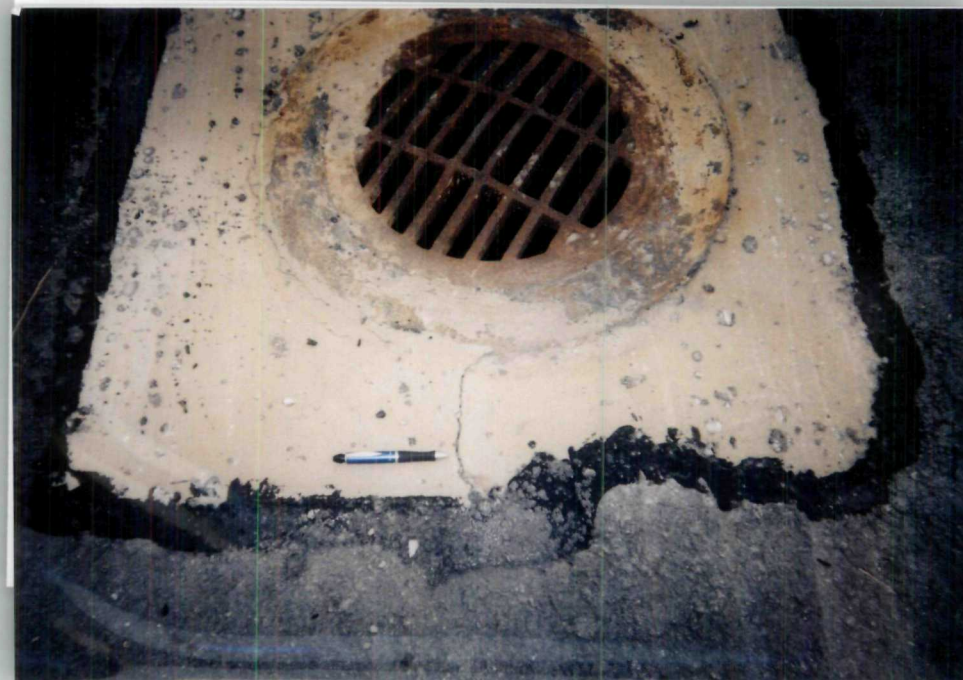
0956 Photo 80-03 looking down at
Catch basin on N. Side of SBPA Cap.
Note Crack in Concrete.

Description: Photo facing down showing catch basin on
 north side of SBPA cap. Note crack in
 concrete near pencil.

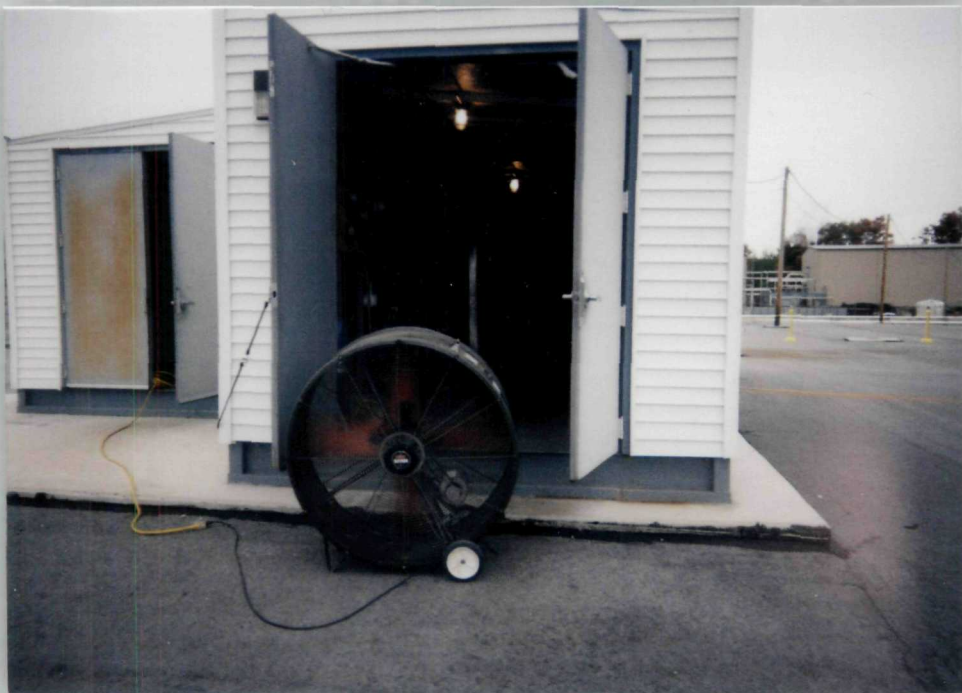
Description: Photo facing west showing fan used to ventilate ISVE blower shed to remove VOCs detected inside.

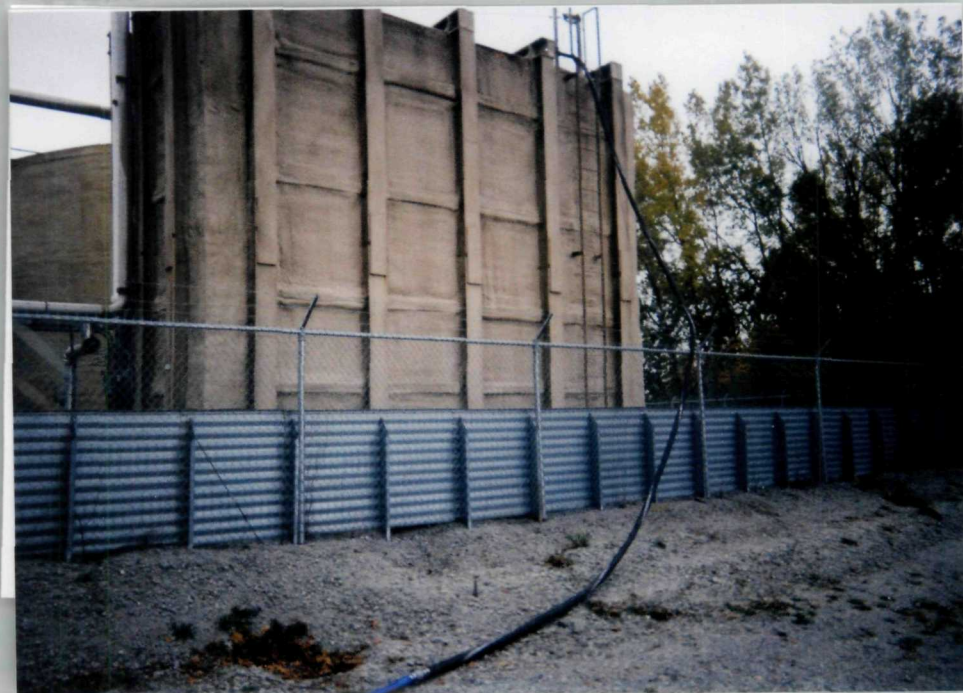
Description: Photo facing southeast showing discharge hose set up to discharge pump test water to equalization tank for treatment.

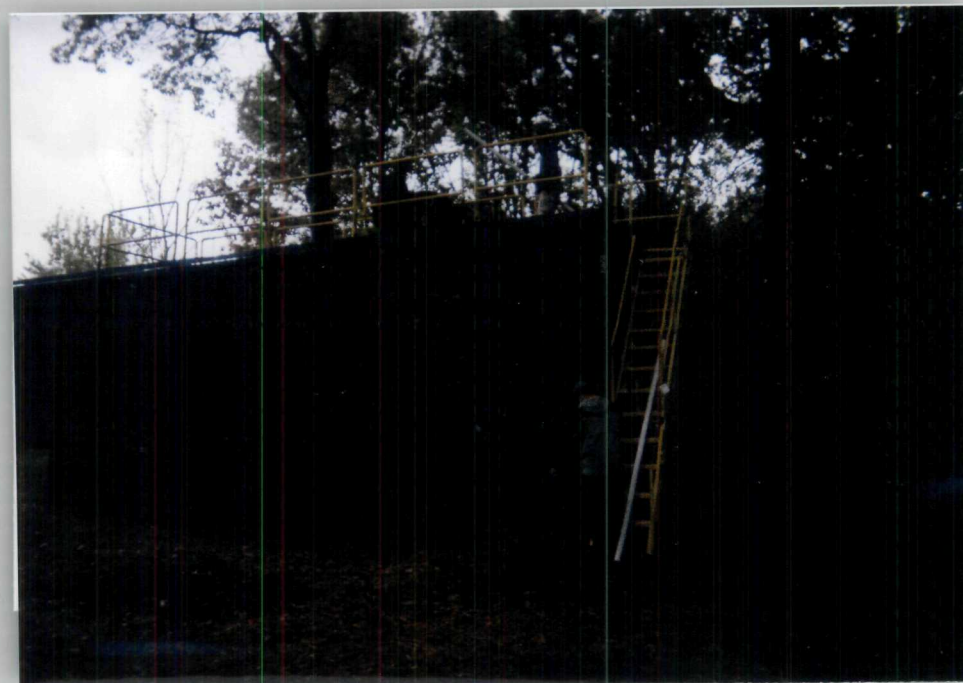
Description: Photo facing north showing MWH personnel on Baker tank making connection for discharge of stored water from the lower aquifer pumping tests

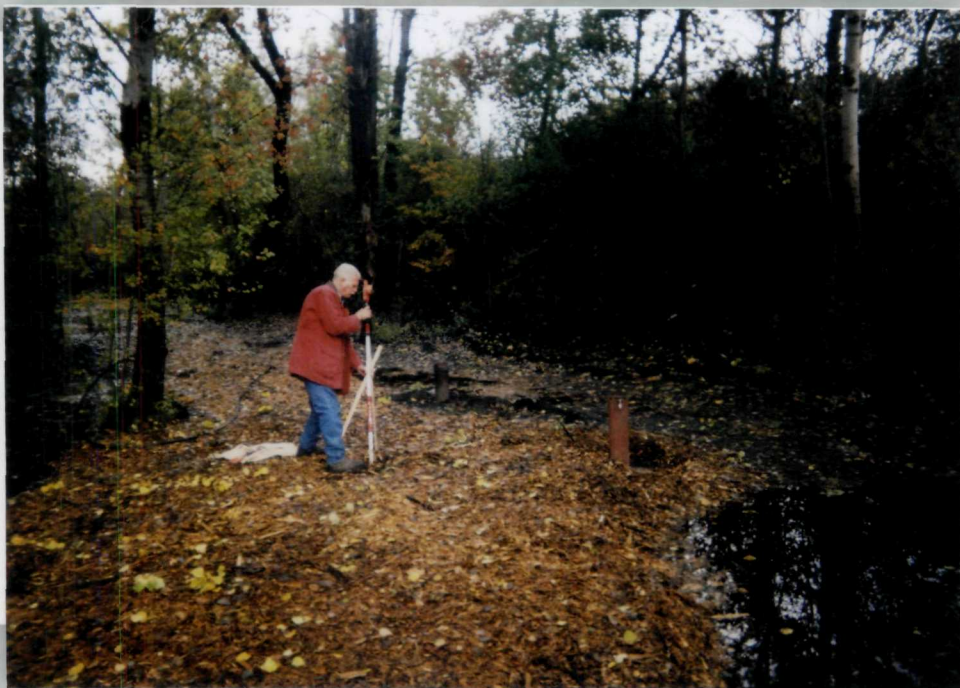
Site: American Chemical Service, Inc.
 Proj. #: 44728 AES [46526 RAC]

Description: Photo facing west showing Area Survey personnel surveying location and elevation of lower aquifer wells.

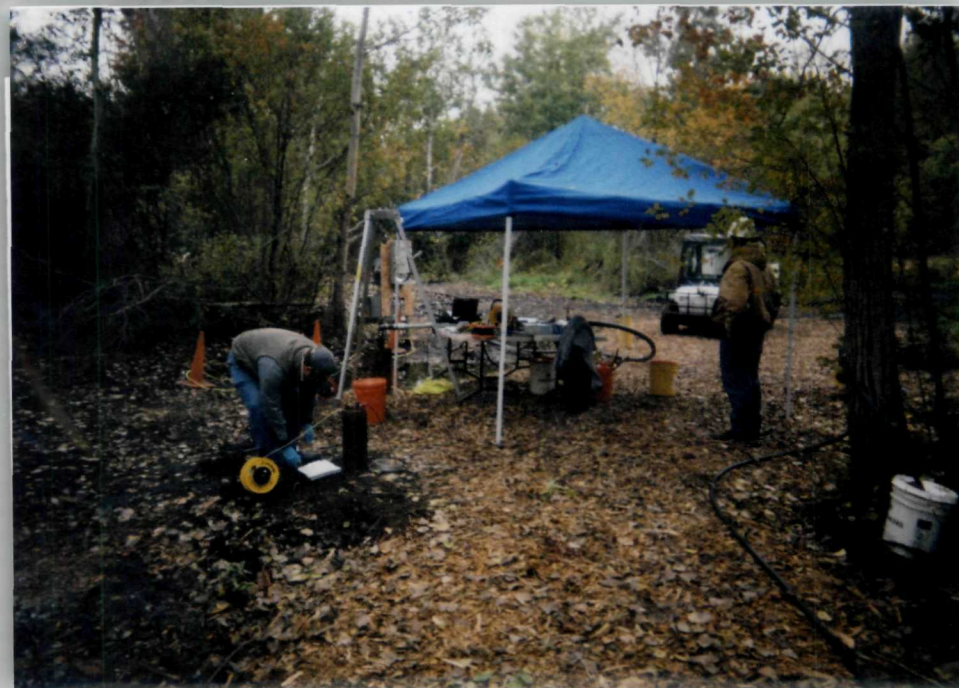
Site: American Chemical Service, Inc.
 Proj. #: 44728 AES [46526 RAC]

Description: Photo facing east showing MWH taking water level readings at LA EW02 prior to the step pumping test.

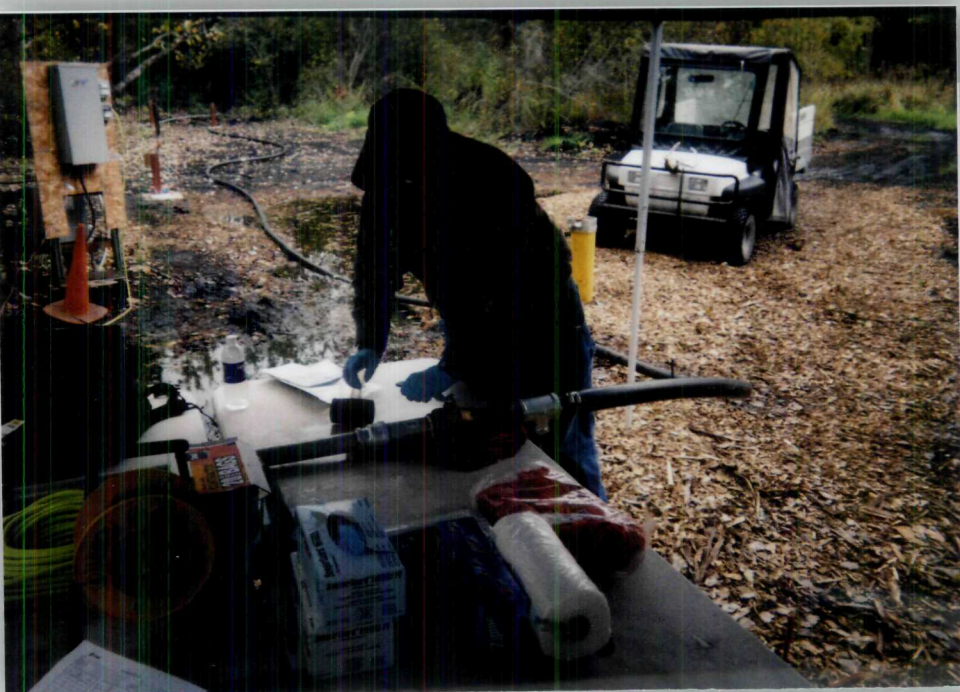
Site: American Chemical Service, Inc.
 Proj. #: 44728 AES [46526 RAC]
 Roll: 80 Photo #10
 Date: 10-27-05 Time: 1430
 Photographer: Larry Campbell
 Description: Photo facing east showing MWH personnel
 adjusting discharge valve to increase
 discharge from 30 to 40 gpm.

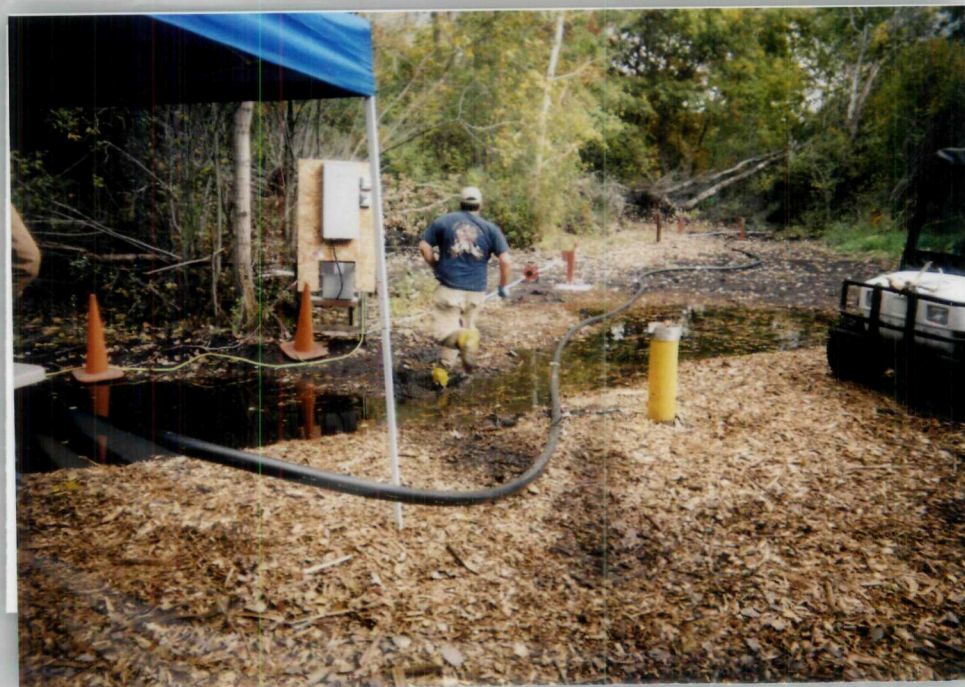
Site: American Chemical Service, Inc.
 Proj. #: 44728 AES [46526 RAC]
 Roll: 80 Photo #11
 Date: 10-27-05 Time: 1434
 Photographer: Larry Campbell
 Description: Photo facing east showing MWH personnel
 running to LA12 to measure water level
 during lower aquifer step pumping test.

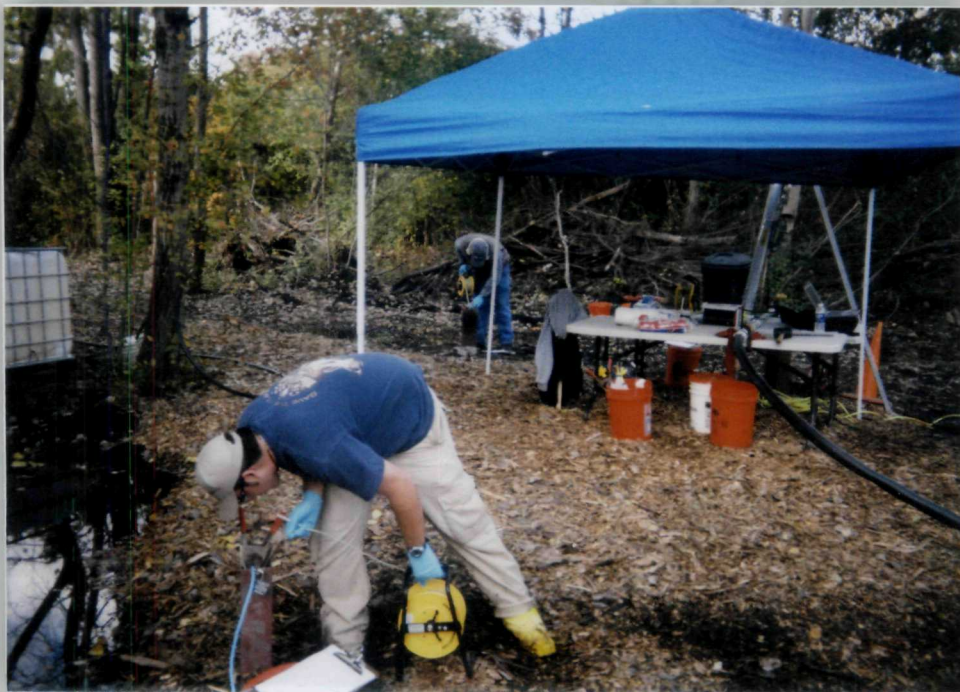
Description: Photo facing northwest showing MWH staff measuring water level at EW02 and OW01 for lower aquifer step pumping test, pumping at 50 gpm.

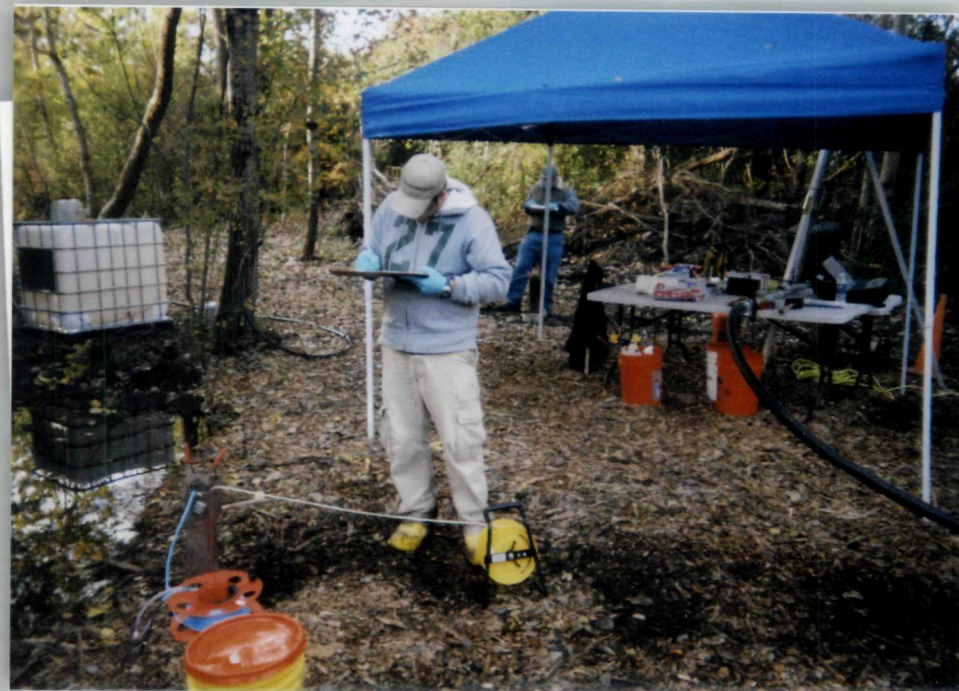
Description: Photo facing northwest showing MWH staff recording water levels during recover test following conclusion of step pumping test

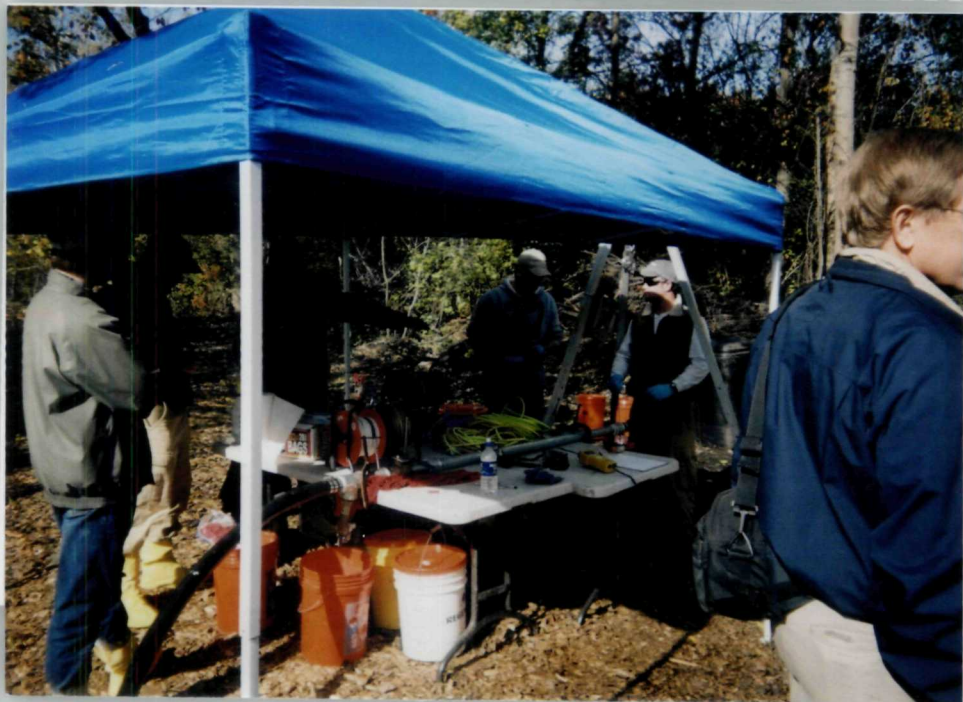
Site: American Chemical Service, Inc.
 Proj. #: 44728 AES [46526 RAC]

Description: Photo facing northwest showing setup at
 EW02. Lee Orosz is conducting safety
 briefing for conduct of the pumping test.

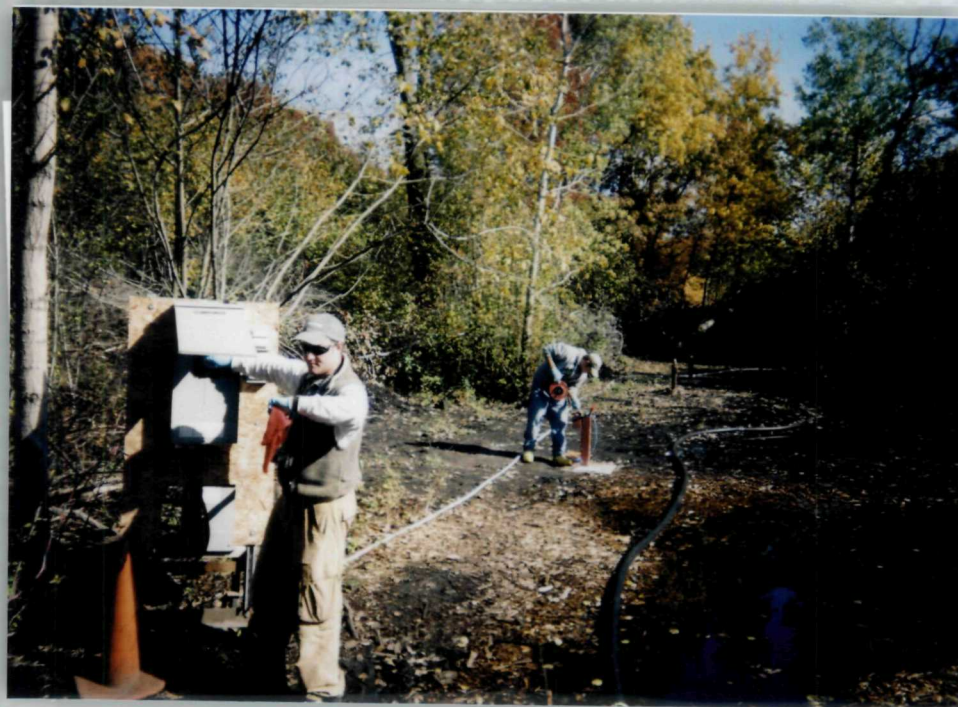
Description: Photo facing northeast showing Dave
 Powers turning on power to pump to start
 the long term lower aquifer pumping test.
 Note measuring water level in background.

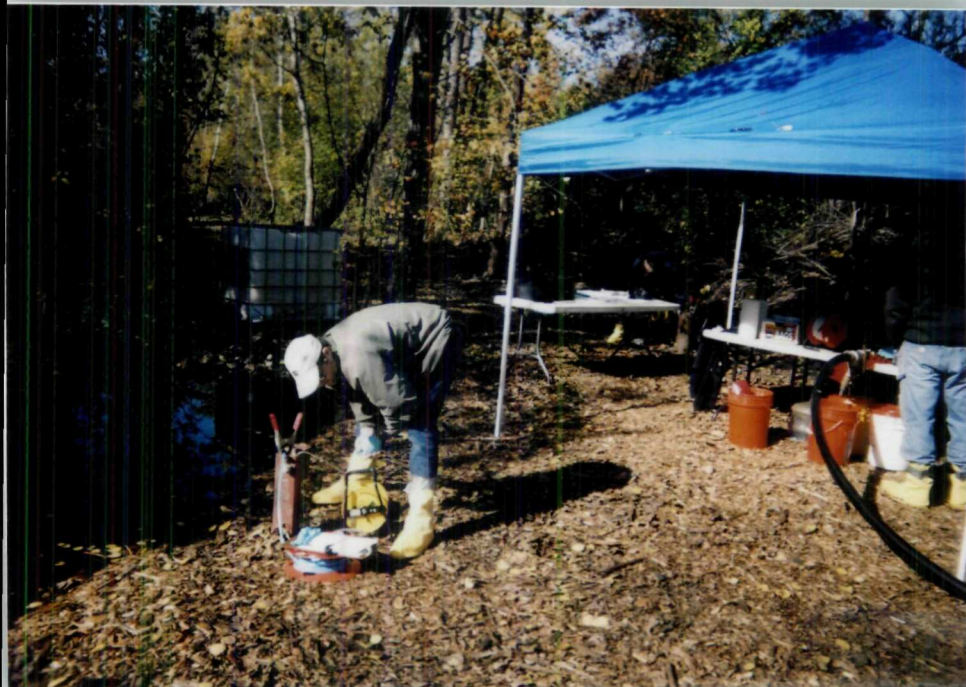
Site: American Chemical Service, Inc.
 Proj. #: 44728 AES [46526 RAC]
 Roll: 80 Photo #18
 Date: 11-01-05 Time: 1201
 Photographer: Larry Campbell
 Description: Photo facing northwest showing Kevin Adler measuring water level at OW01.

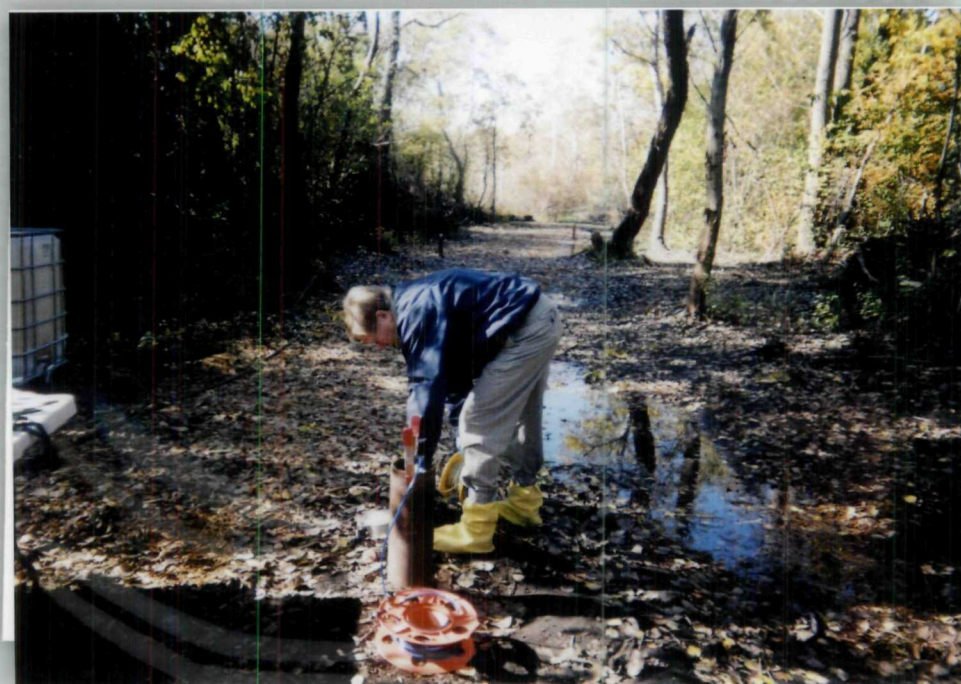
Site: American Chemical Service, Inc.
 Proj. #: 44728 AES [46526 RAC]
 Roll: 80 Photo #19
 Date: 11-01-05 Time: 1205
 Photographer: Larry Campbell
 Description: Photo facing west showing Pete Vagt measuring water level at MW53.

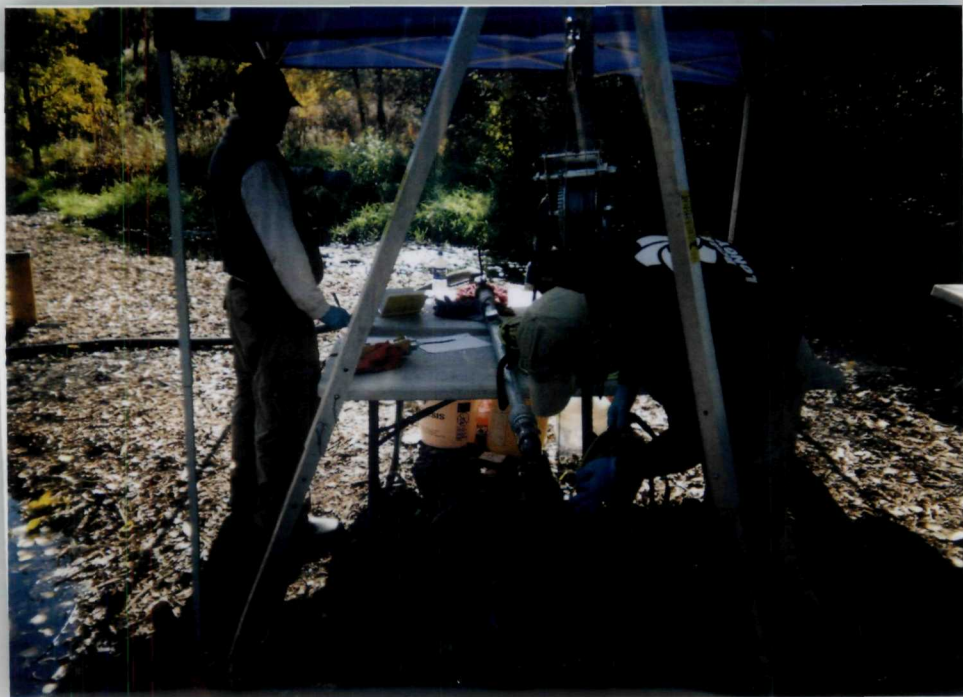
Description: Photo facing south showing Chad Smith measuring water level in EW02. Dave Powers is monitoring flow meter.

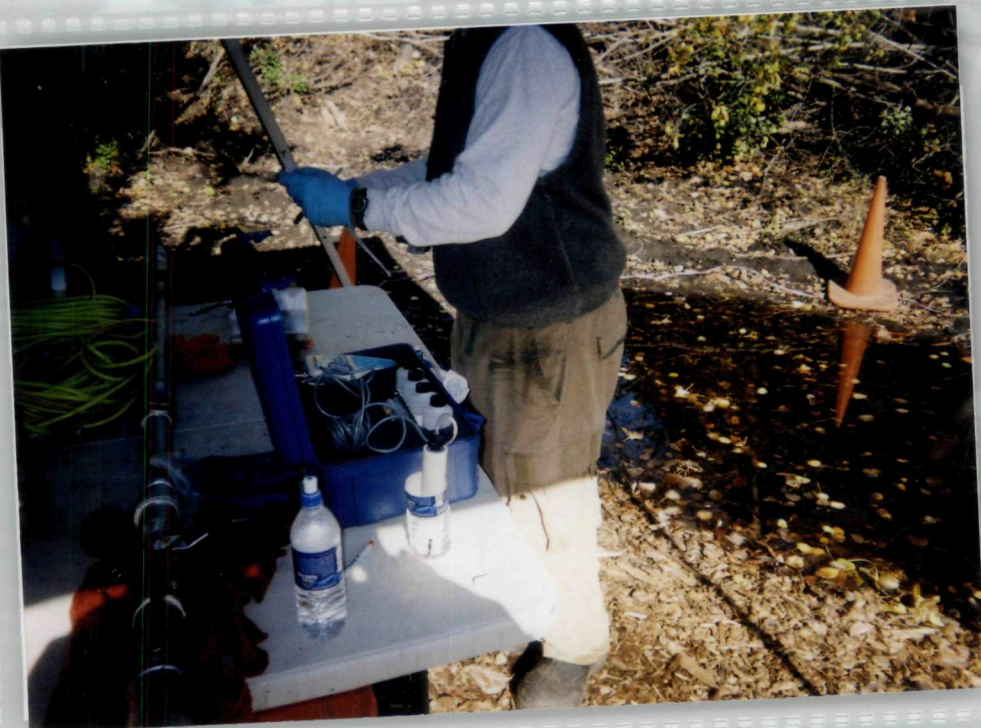
Site: American Chemical Service, Inc.
 Proj. #: 44728 AES [46526 RAC]
 Roll: 80 Photo #22
 Date: 11-01-05 Time: 1215
 Photographer: Larry Campbell
 Description: Photo facing north showing Dave Powers
 checking conductivity of sampled water.

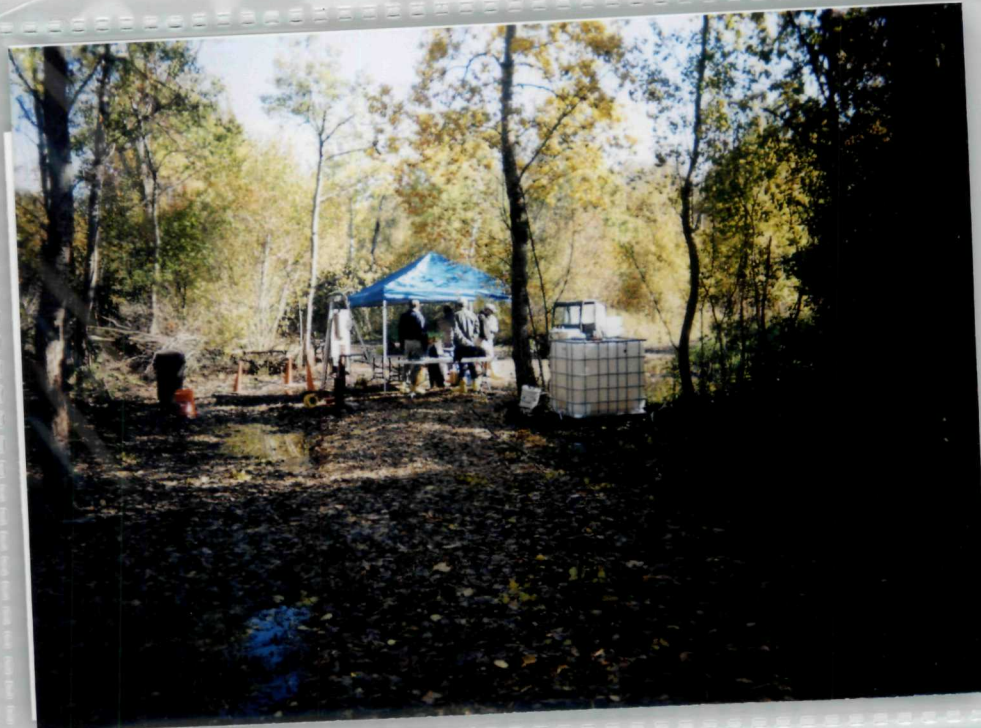
Site: American Chemical Service, Inc.
 Proj. #: 44728 AES [46526 RAC]
 Roll: 80 Photo #23
 Date: 11-01-05 Time: 1232
 Photographer: Larry Campbell
 Description: Photo facing east showing pump test setup.
 Staff is resting between water level readings.

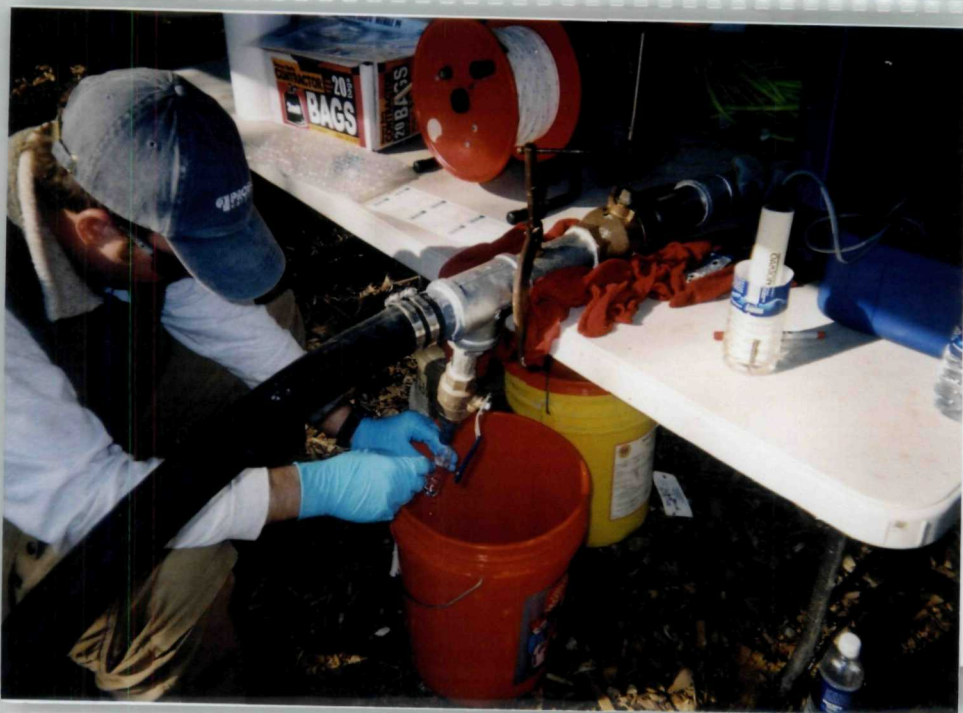
Site: American Chemical Service, Inc.
 Proj. #: 44728 AES [46526 RAC]
 Roll: 80 Photo #24
 Date: 11-01-05 Time: 1300
 Photographer: Larry Campbell
 Description: Photo facing northwest showing Dave Powers collecting VOC samples from pump test discharge piping.

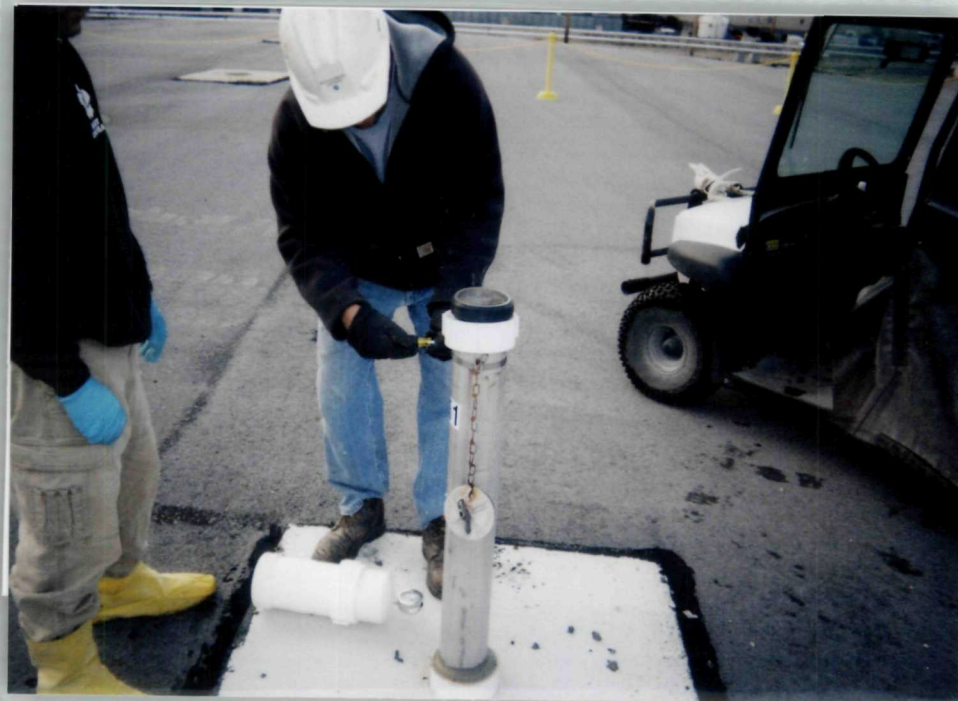
Site: American Chemical Service, Inc.
 Proj. #: 44728 AES [46526 RAC]
 Roll: 80 Photo #25
 Date: 11-01-05 Time: 1525
 Photographer: Larry Campbell
 Description: Photo facing west showing Lee Orosz installing new 150 psi pressure caps on ISVE well 51.

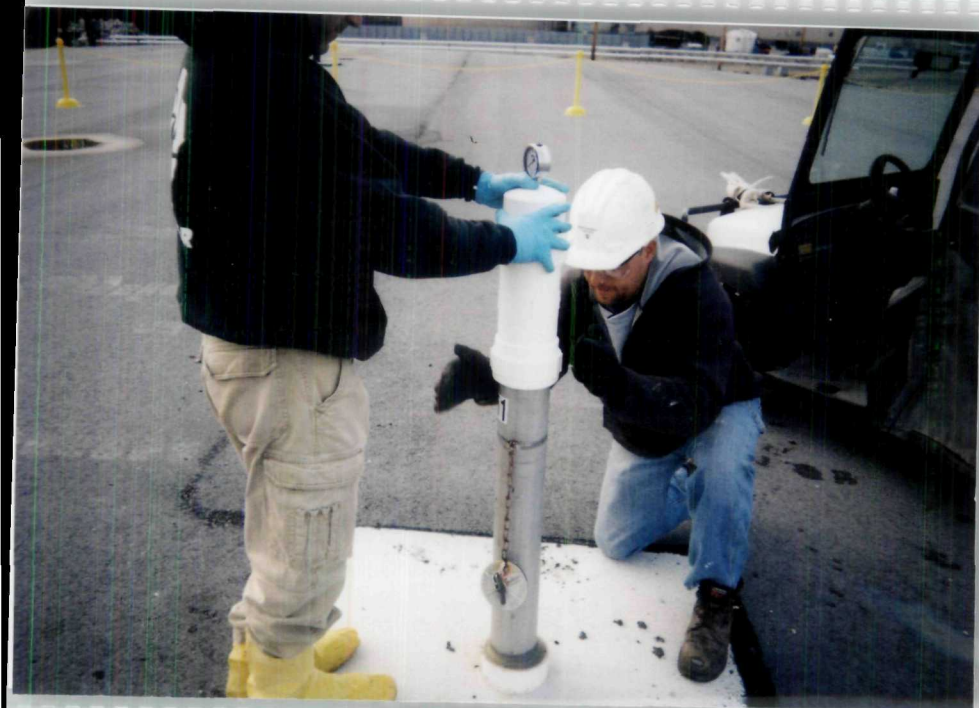
Site: American Chemical Service, Inc.
 Proj. #: 44728 AES [46526 RAC]
 Roll: 80 Photo #26
 Date: 11-01-05 Time: 1526
 Photographer: Larry Campbell
 Description: Photo facing west showing newly installed well cap.

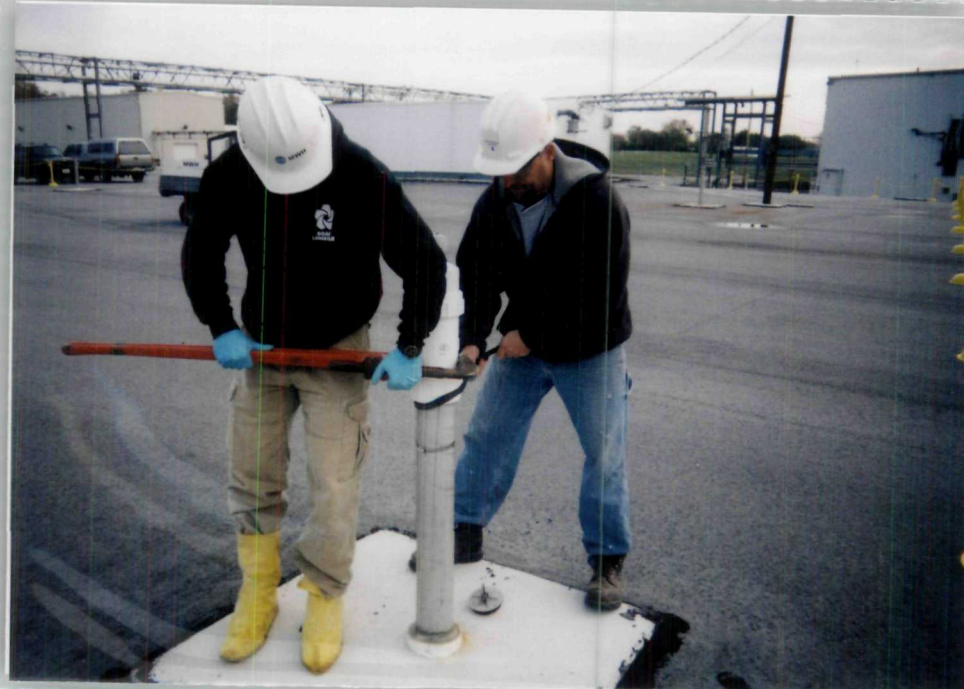
Site: American Chemical Service, Inc.
 Proj. #: 44728 AES [46526 RAC]
 Roll: 80 Photo #27
 Date: 11-01-05 Time: 1530
 Photographer: Larry Campbell
 Description: Photo facing southeast showing MWH tightening new cap on ISVE 44.
